**Collision With Trees on Final Approach
Federal Express Flight 1478
Boeing 727-232, N497FE
Tallahassee, Florida
July 26, 2002**

NTSB/AAR-04/02

**NTSB/AAR-04/02
PB2004-910402
Notation 7501B
Adopted June 8, 2004**

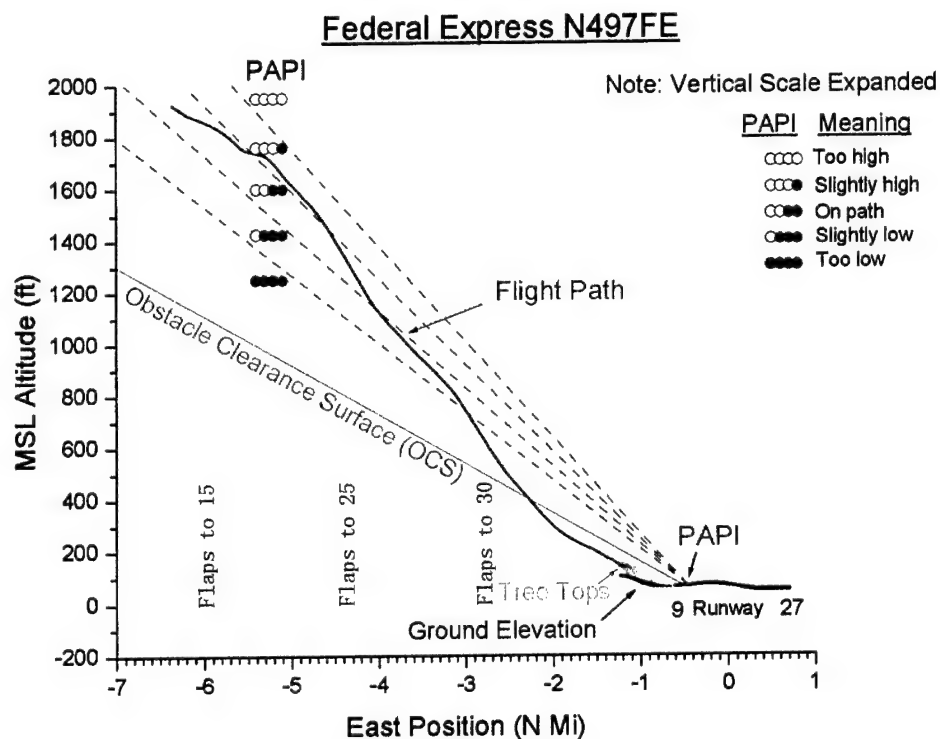
Figure 1. Descent profile of FedEx flight 1478.

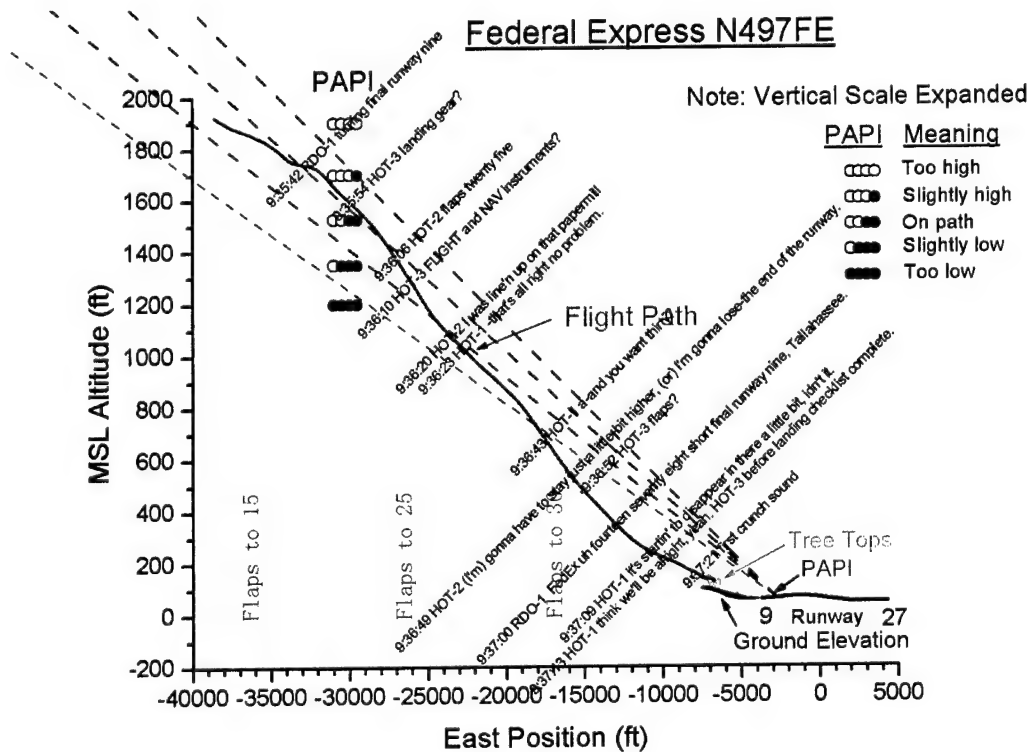
Figure 2. Descent profile of FedEx flight 1478, with select CVR comments overlaid.

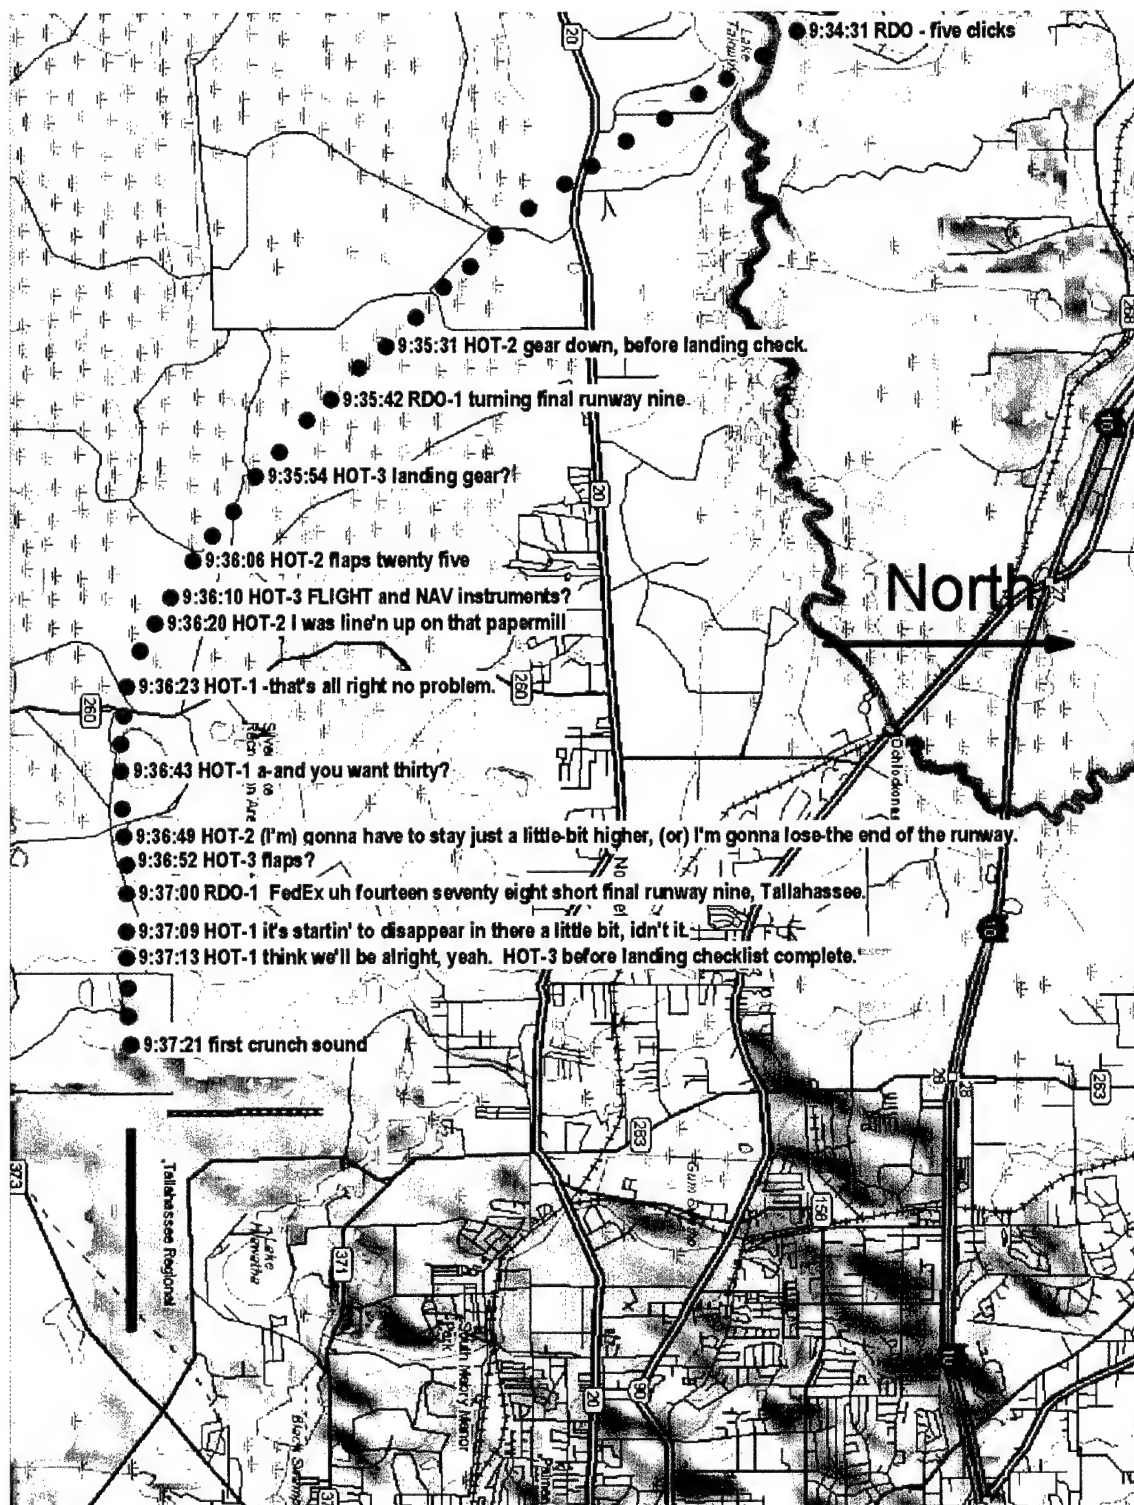
Figure 3. A map overlay of FedEx flight 1478's radar track into runway 9 at TLH, with excerpted CVR comments.

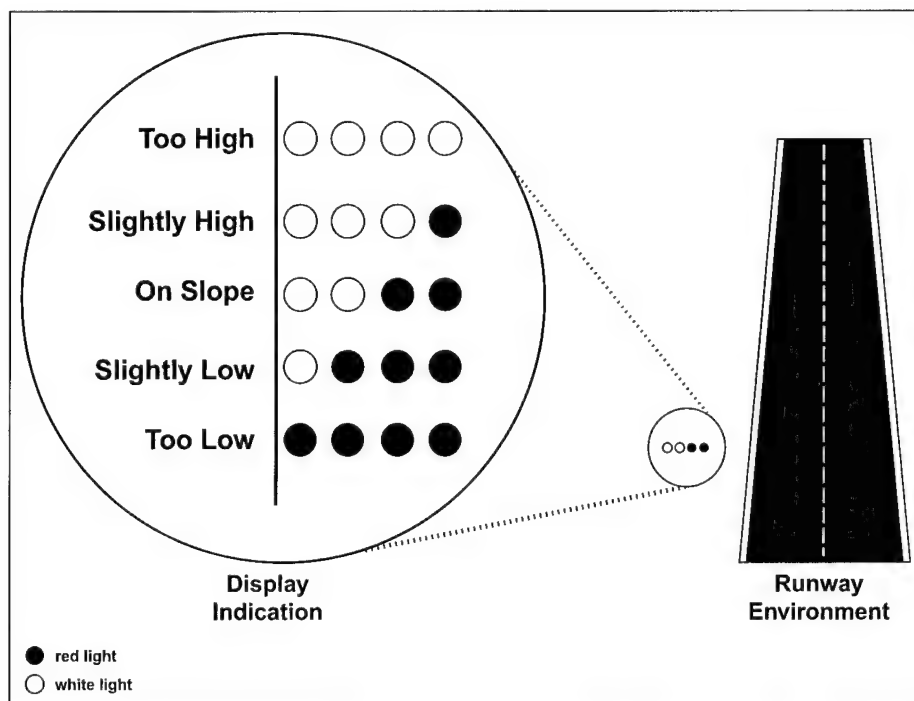
Figure 6. PAPI indications from various approach path angles.
